FIG. 255.—LOWER DAM, OR "PRESA DE LA OLLA," GUANAJUATO, MEXICO. VIEW TAKEN DURING THE FEAST DAY WHEN THE GATES ARE RAISED AND THE RESERVOIR EMPTIED.

The chapter on Masonry Dams has been increased twofold by an attempt to make some mention of all the most notable dams of the world, and many that are very little known. Attention is particularly directed to Plates 1, 2, and 3, in which profiles are shown of all of the leading and better known masonry dams in existence, drawn to uniform scale for easy graphical comparison. No such complete collection of dam profiles has ever before appeared in print, assembled together on a common basis.

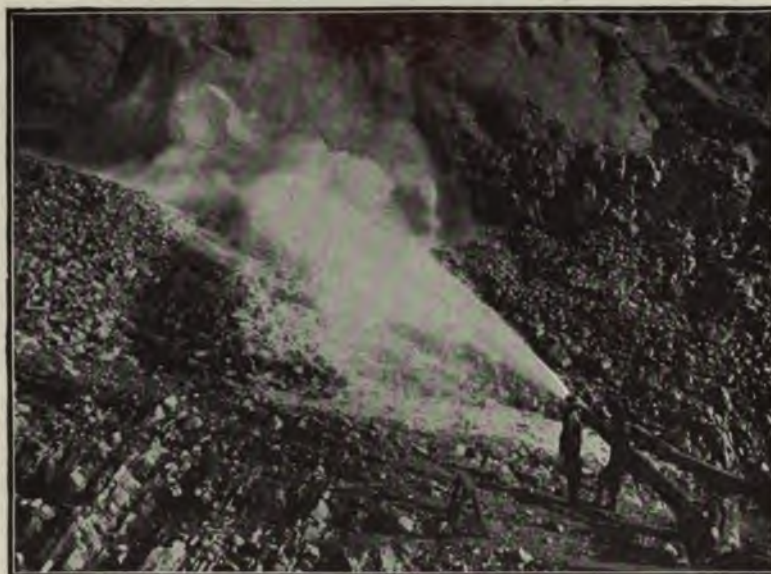
FIG. 118.—STONE CARRIED THROUGH FLUME TO UP-STREAM SLOPE OF THE NECAXA DAM.

of 60% to 70% mingled with stones of all sizes. The photographs, Figs. 118, 119, 120, 121, and 124 show the nature of the materials delivered to each and the manner of delivery.

A striking feature of this work, as illustrated by the photographs, Figs. 118 and 119, taken by the author in January, 1908, is the large size of rocks which have been transported through the flumes and deposited on the dam. Many of these contain upwards of 15 cubic feet and weigh over 1 ton. In this respect the magnitude of the operation exceeds any hydraulic sluicing ever before attempted. The down-stream slope is being covered with 2 feet of masonry laid in Portland cement, using

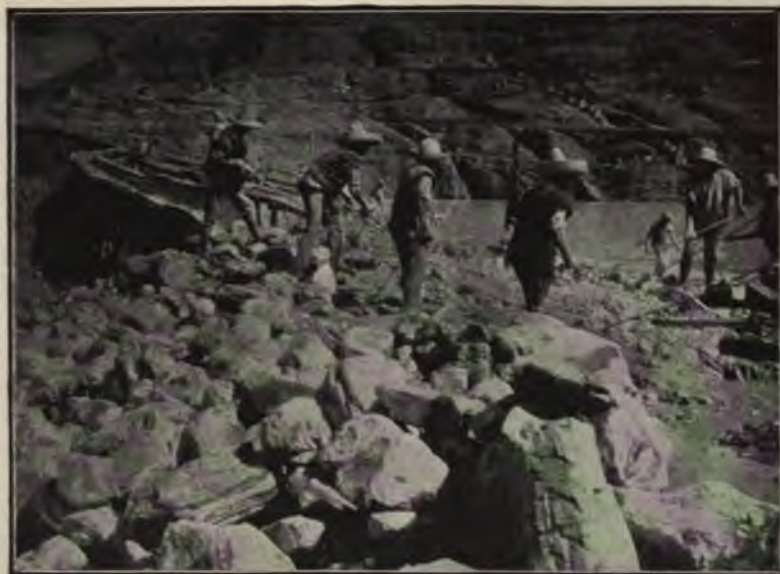
FIG. 119.—ILLUSTRATING THE SIZE OF STONE DELIVERED BY FLUME TO THE NECAXA DAM. THE LARGEST ONE MEASURED CONTAINED 18 CUBIC FEET.

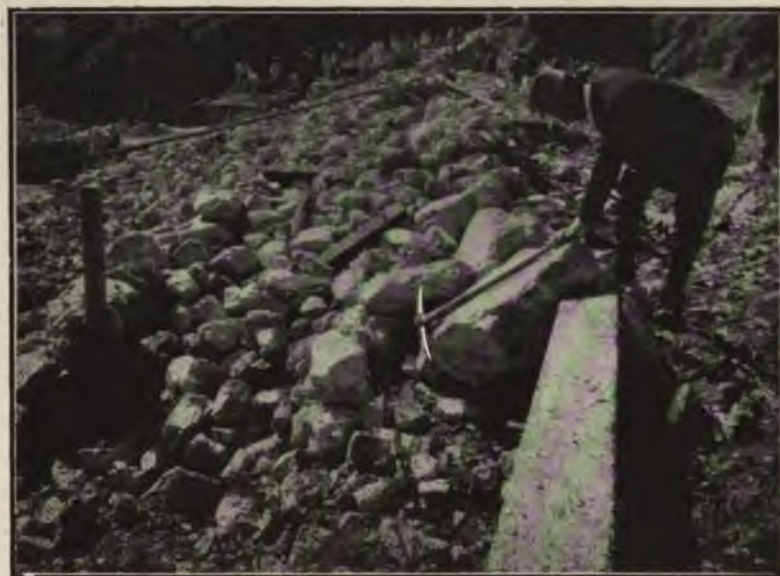
FIG. 120.—LOWER TOE OF NECAXA DAM, LOOKING NORTH, SHOWING DELIVERY OF ROCK AND CLAY BY FLUME.

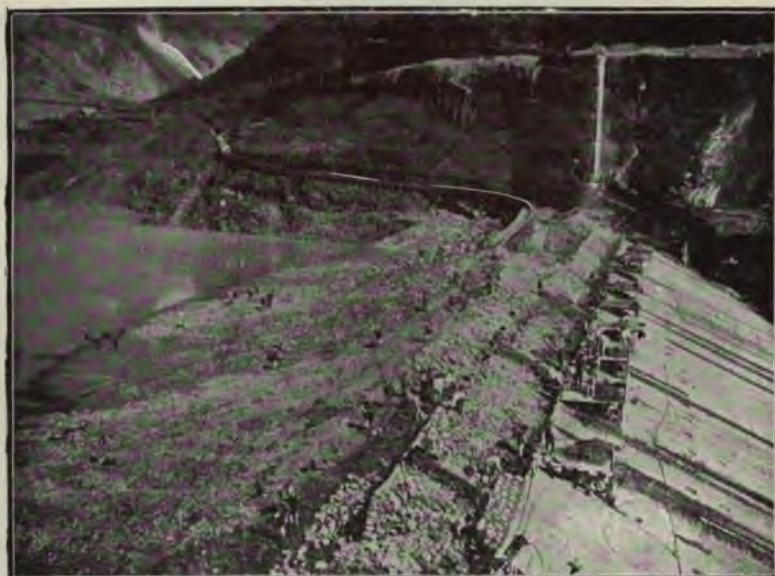
FIG. 121.—DOWN-STREAM SLOPE OF NECAXA DAM, SHOWING MASONRY PAVEMENT ON FACE AND CHARACTER OF SLICED MATERIAL.

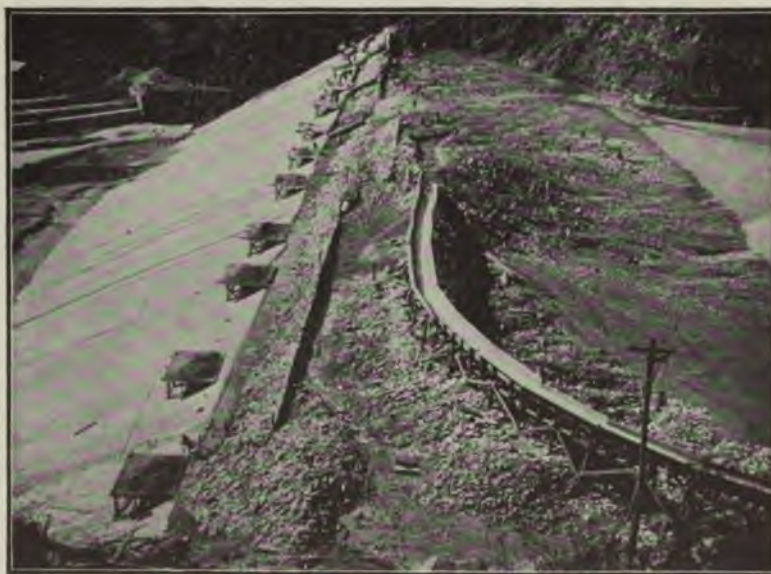
FIG. 122.—NECAXA DAM FROM BELOW, AT HEIGHT OF 85 FEET. JANUARY 1, 1908.

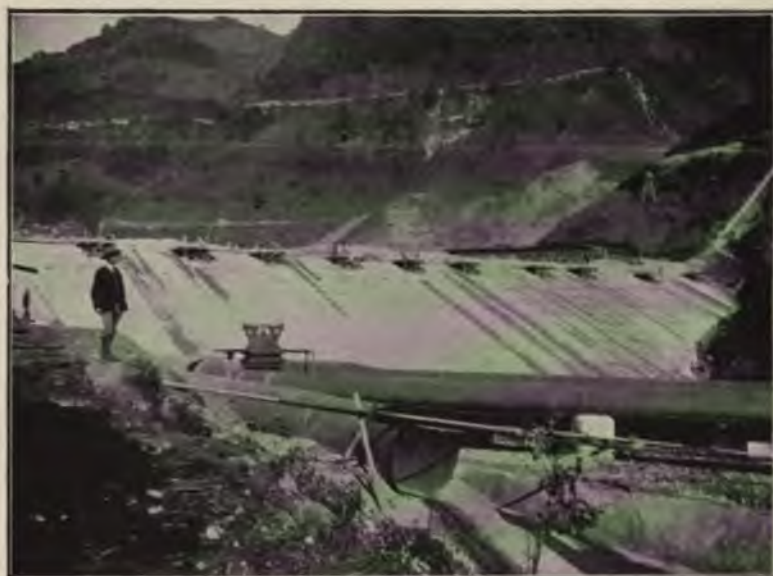
FIG. 123.—NECAXA DAM AND RESERVOIR. SLUICE DITCH IN UPPER RIGHT-HAND CORNER OF PICTURE.

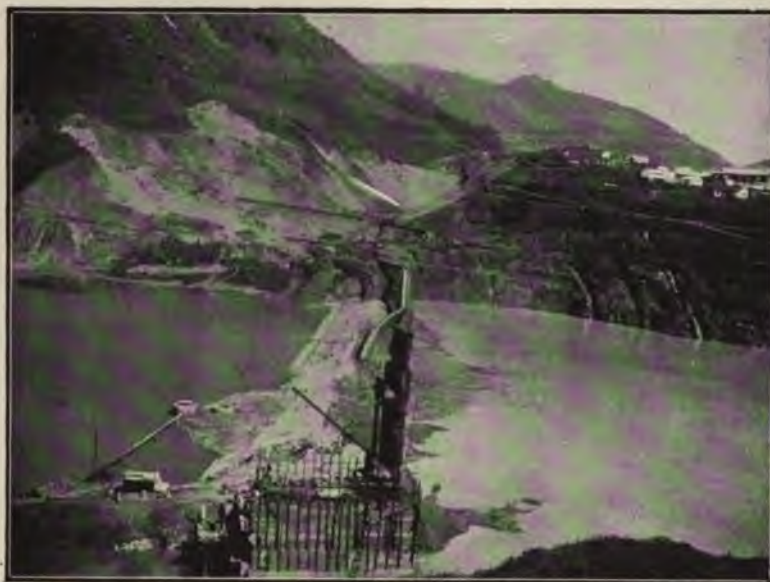
FIG. 124.—NECAXA DAM, UP-STREAM SLOPE, LOOKING TOWARD SLUICING PIT AND SPILLWAY GAP.

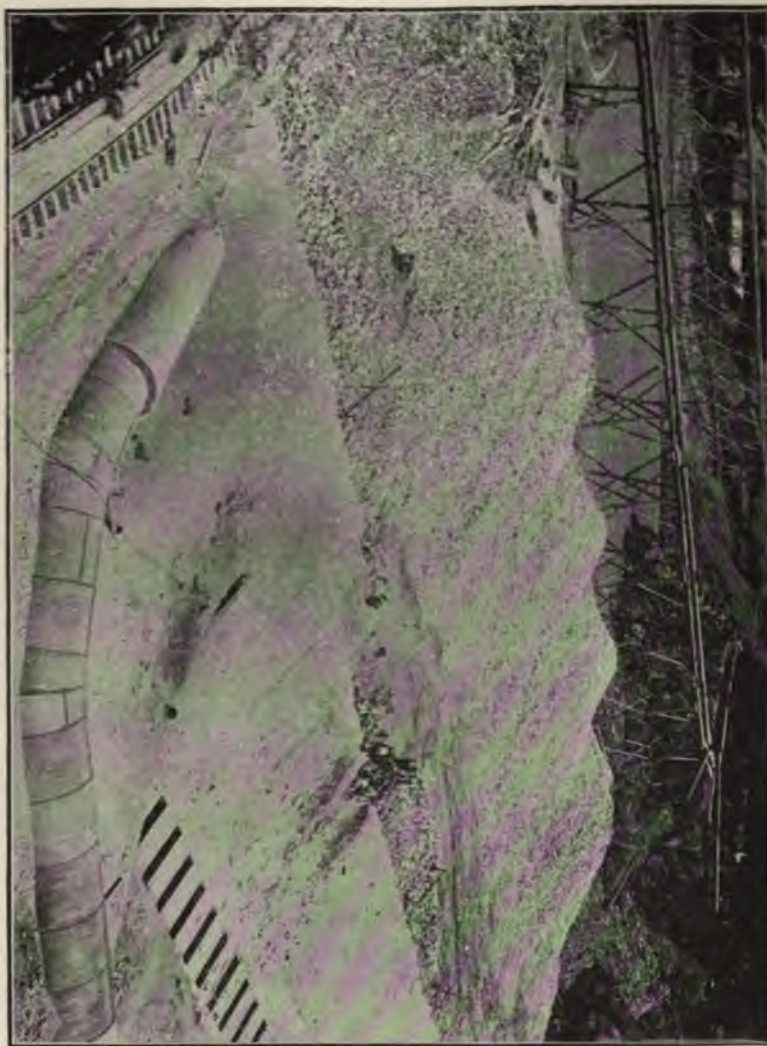
FIG. 126.—LOWER TOE OF NECACAXA DAM, MEXICO, SHOWING CHARACTER OF HYDRAULIC-FILL MATERIAL. PIPE IN FOREGROUND IS 10 FEET IN DIAMETER, USED ONLY FOR FLOOD DISCHARGE DURING CONSTRUCTION.

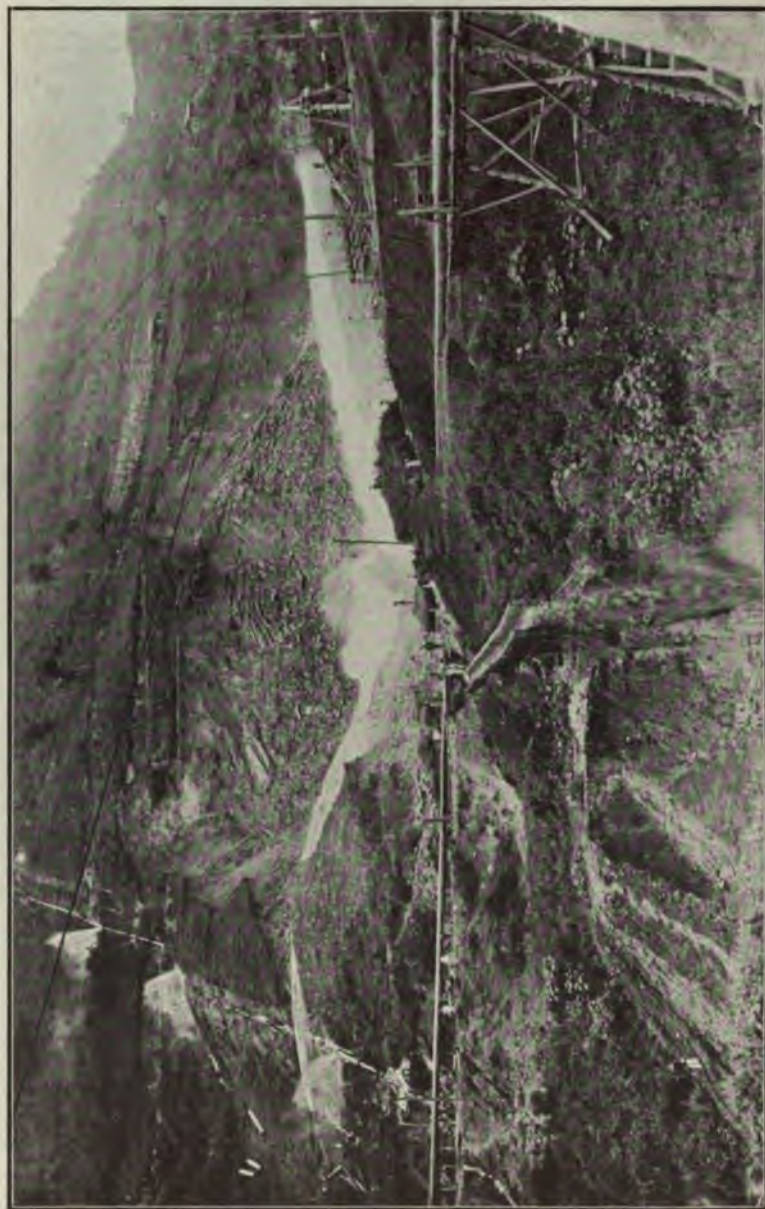
FIG. 127.—HYDRAULIC SLUICING AT NECAXA, JUNE, 1907. SHOWING TILTED LIMESTONE LEDGES IN PIT NO. 1,
OVERLAID BY CLAY AND LOOSE ROCK.

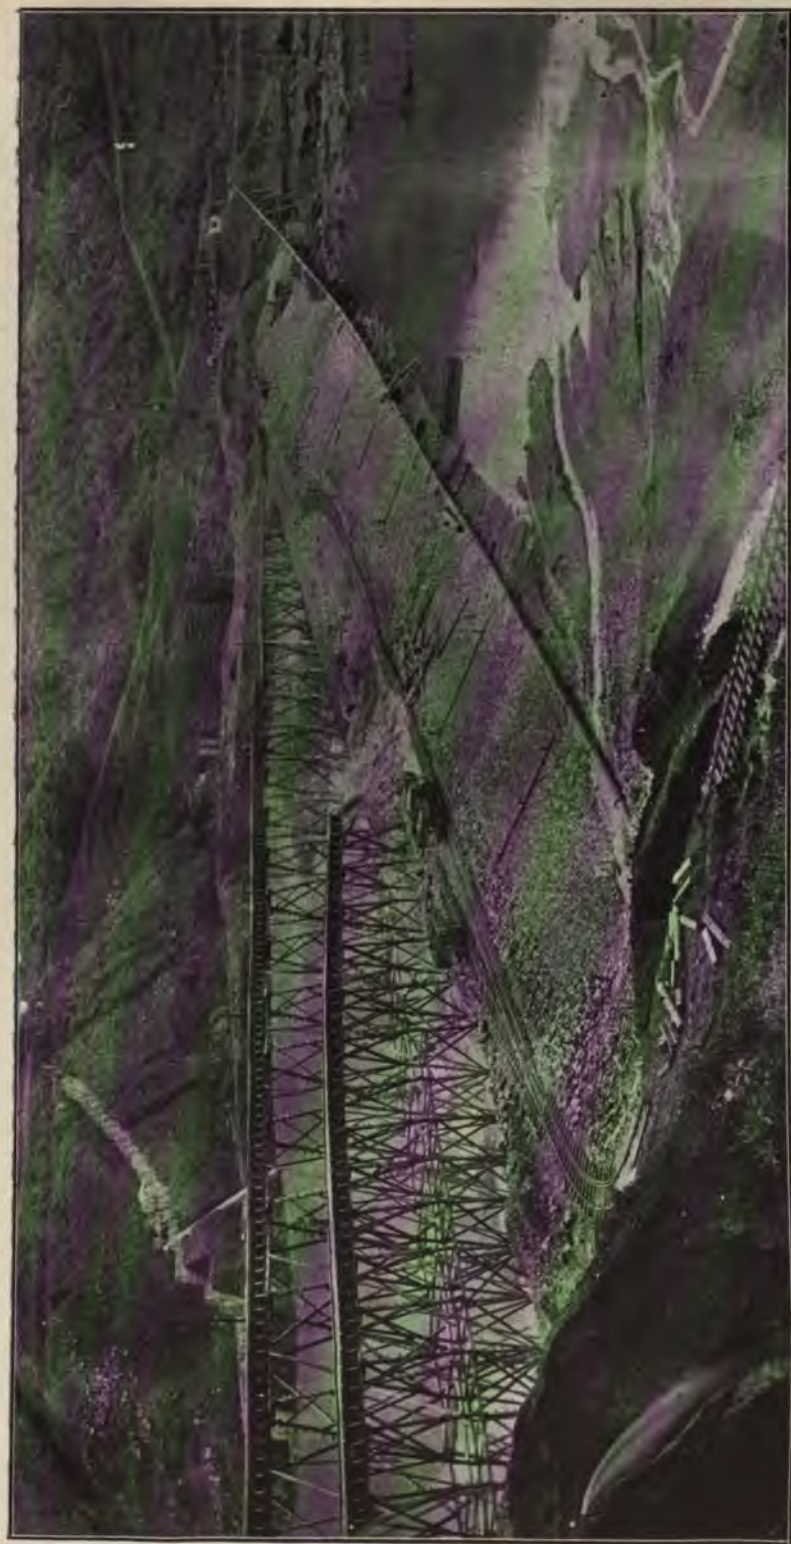
FIG. 128.—NECAXA DAM, MEXICO, OCT. 26, 1907, SHOWING MATERIAL BEING DEPOSITED BY FLUME. ALSO HYDRAULIC ELEVATOR OPERATING UNDER 700 FEET HEAD, LIFTING WATER FROM POND INTO POWER CANAL AT HEADWORKS AT END OF PIPE.

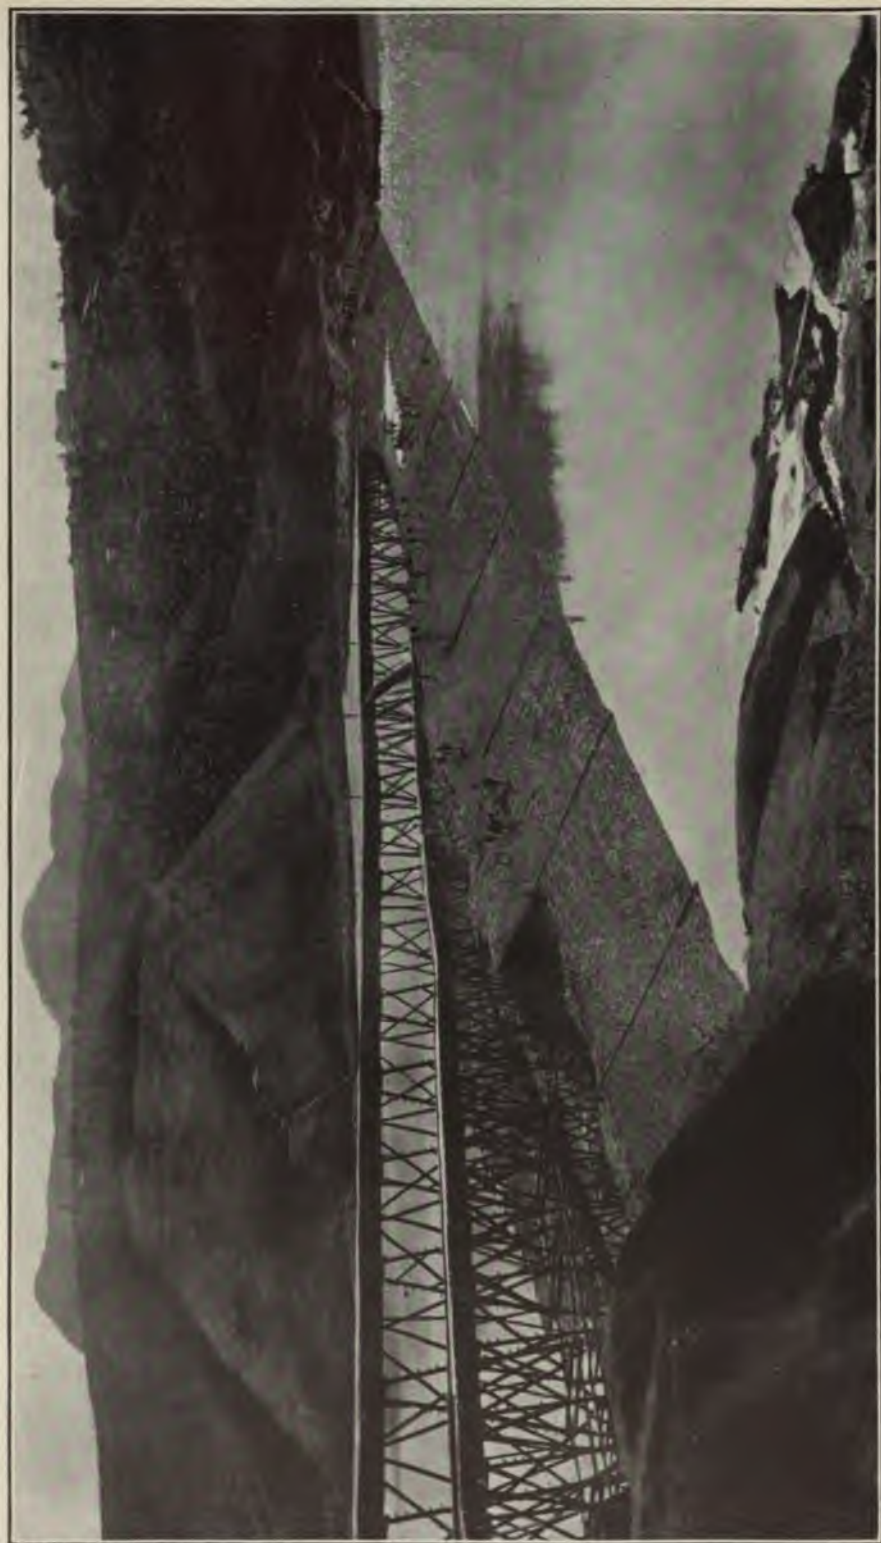
FIG. 129.—UP-STREAM TOE OF NECAXA HYDRAULIC-FILL DAM, DEC. 9, 1907, SHOWING DELIVERY OF MATERIALS BY FLUMES. THE CORE-WALL IS SHOWN
IN CENTER OF DAM.

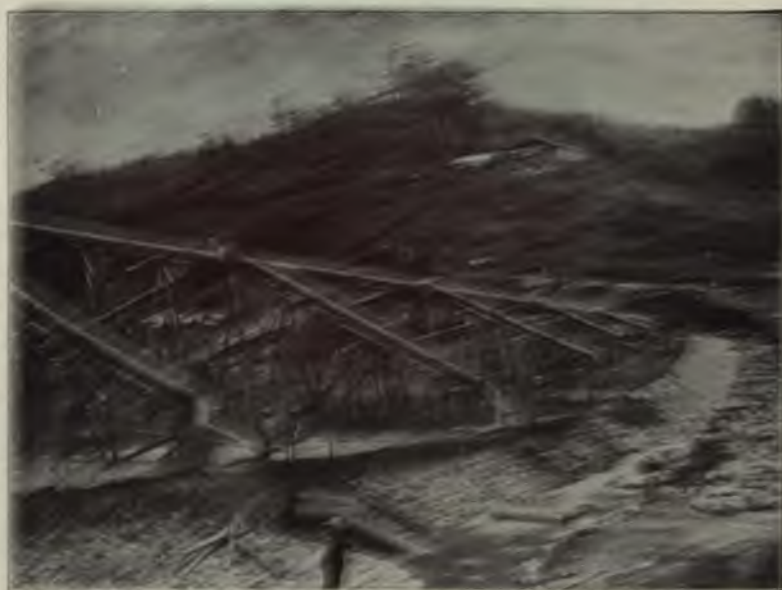
FIG. 130.—LIQUID EARTH BEING DEPOSITED THROUGH PIPES ON OUTER SLOPE OF DAM NO. 1, TENANGO RIVER.

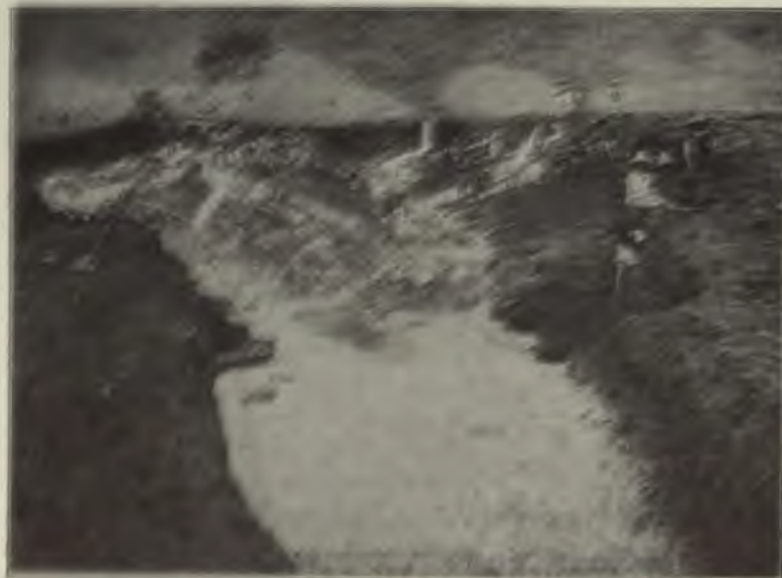
FIG. 131.—GROUND-SLICING ON DAM NO. 1, TENANGO RIVER.

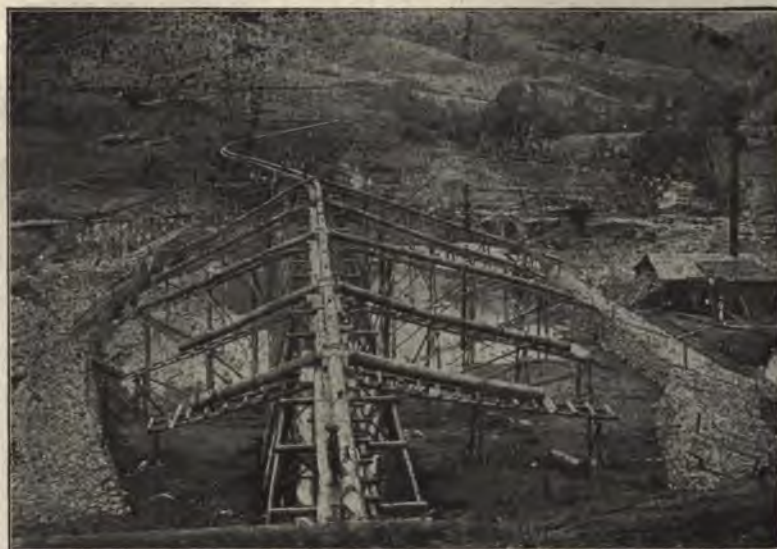
FIG. 132.—METHOD OF DISTRIBUTING SLUICED MATERIALS THROUGH PIPES, DAM No. 1, AT ACATLAN, TENANGO RIVER.

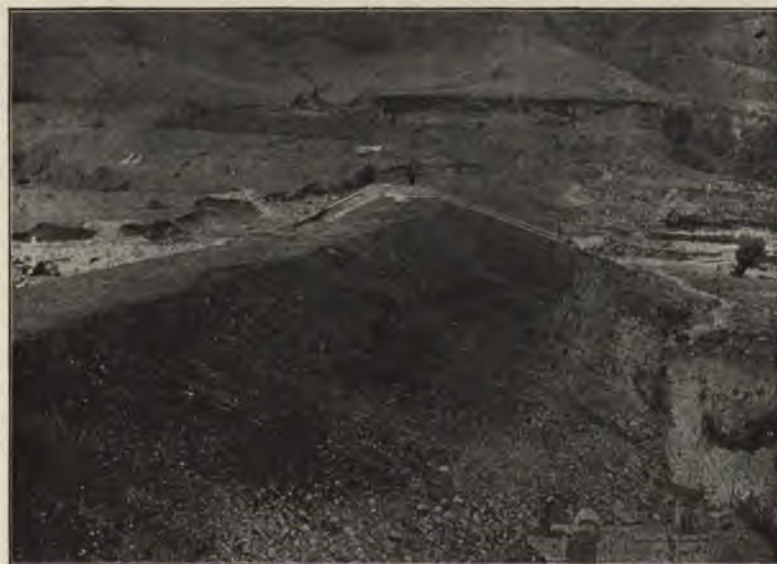
FIG. 133.—DAM No. 1, AT ACATLAN, TENANGO RIVER, COMPLETED JULY, 1906. THE MATERIALS FOR THE DAM WERE GROUND-SLUICED FROM THE BORROW-PITS IN THE BACKGROUND.

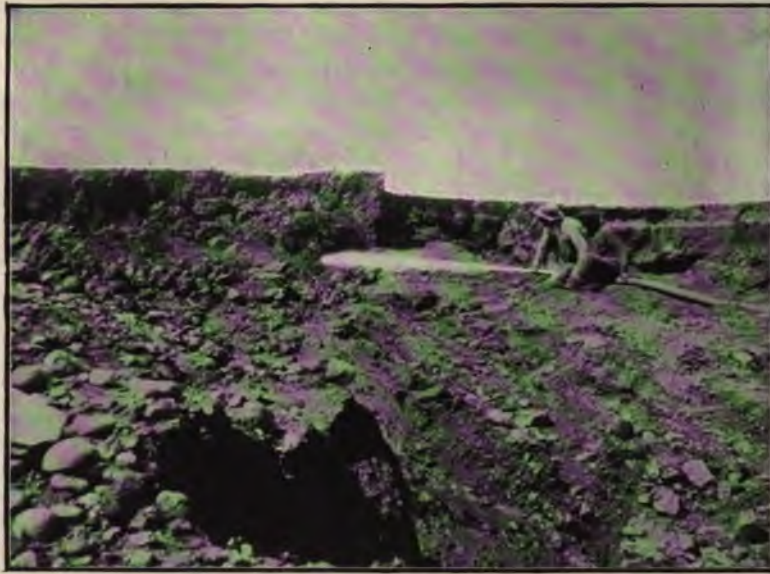
FIG. 134.—YORBA DAM, CALIFORNIA. HYDRAULICKING AN EARTH BANK WITH WATER PUMPED THROUGH 1-INCH NOZZLE UNDER 25 POUNDS PRESSURE.

Fig. 134 shows the operation of hydraulic sluicing, and Fig. 135 illustrates the method of delivery of earth upon the dam. The surplus water was drained from the pond through stand-pipes built up in successive layers and connecting with the main outlet-pipe through which the water was fed into the reservoir. The entire cost of the dam was about \$38,000.

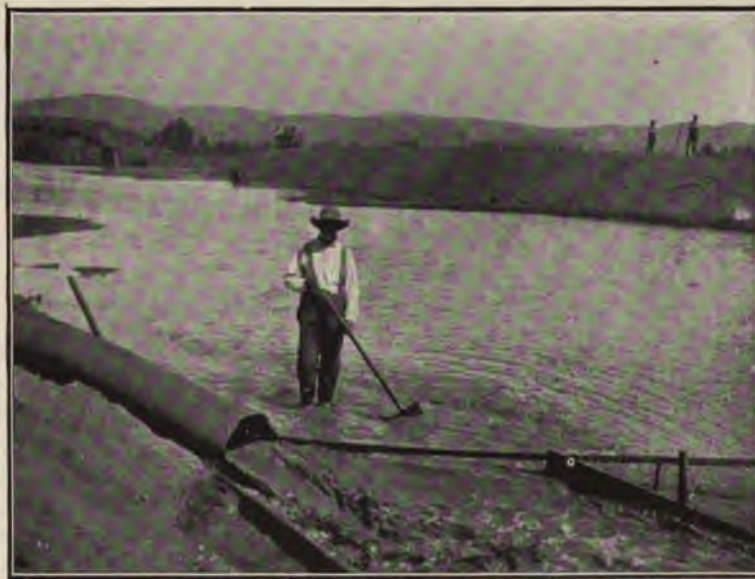
FIG. 135.—YORBA DAM, CALIFORNIA. SHOWING DISCHARGE OF PUMPED MATERIAL, ALONG UP-STREAM TOE LEVEE.

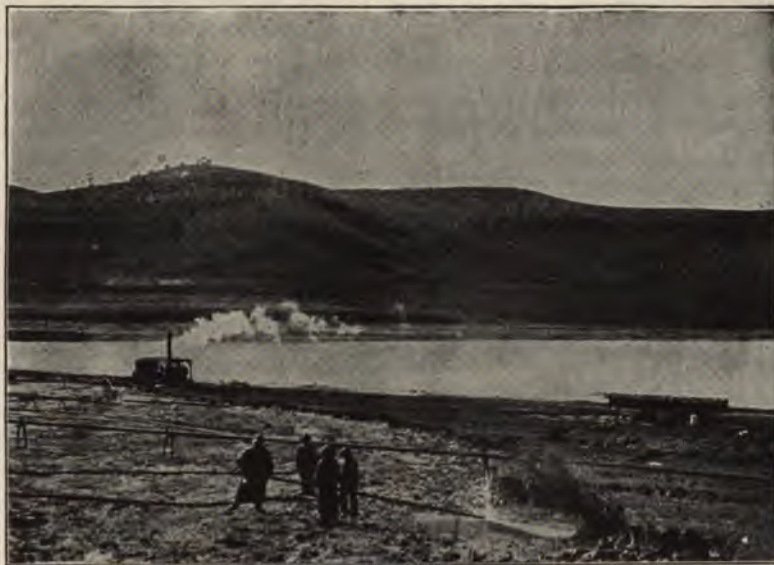
FIG. 136.—SILVER LAKE DAM, LOS ANGELES. THE EARTH, LOOSENED BY THE HYDRAULIC JET, IS CONVEYED TO THE PUMPING STATION SHOWN AND PUMPED TO THE DAM.

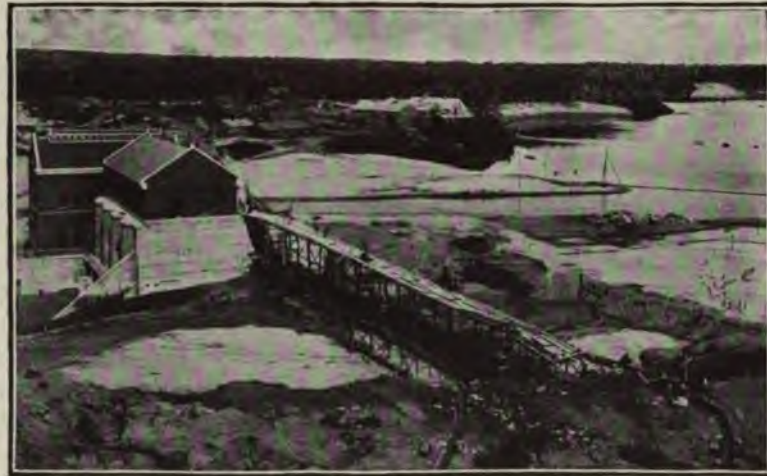
FIG. 137.—CROTON HYDRAULIC-FILL DAM, MICHIGAN, DURING CONSTRUCTION.

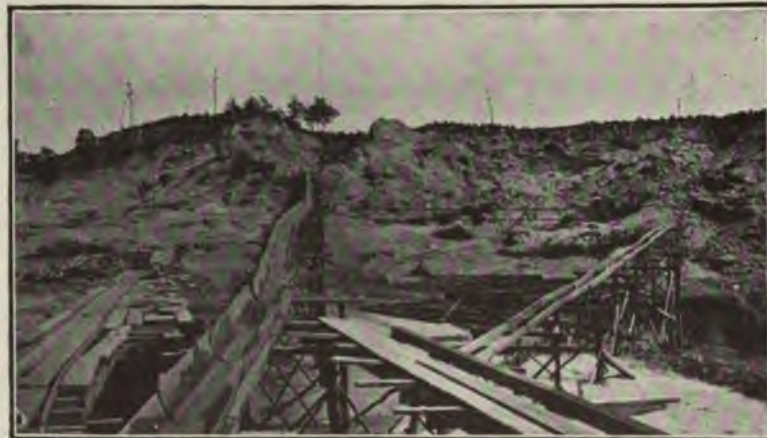
FIG. 138.—CROTON DAM, MICHIGAN, ILLUSTRATING FLUMES AND TRESTLE SUPPORTS USED IN HYDRAULIC SLUICING.

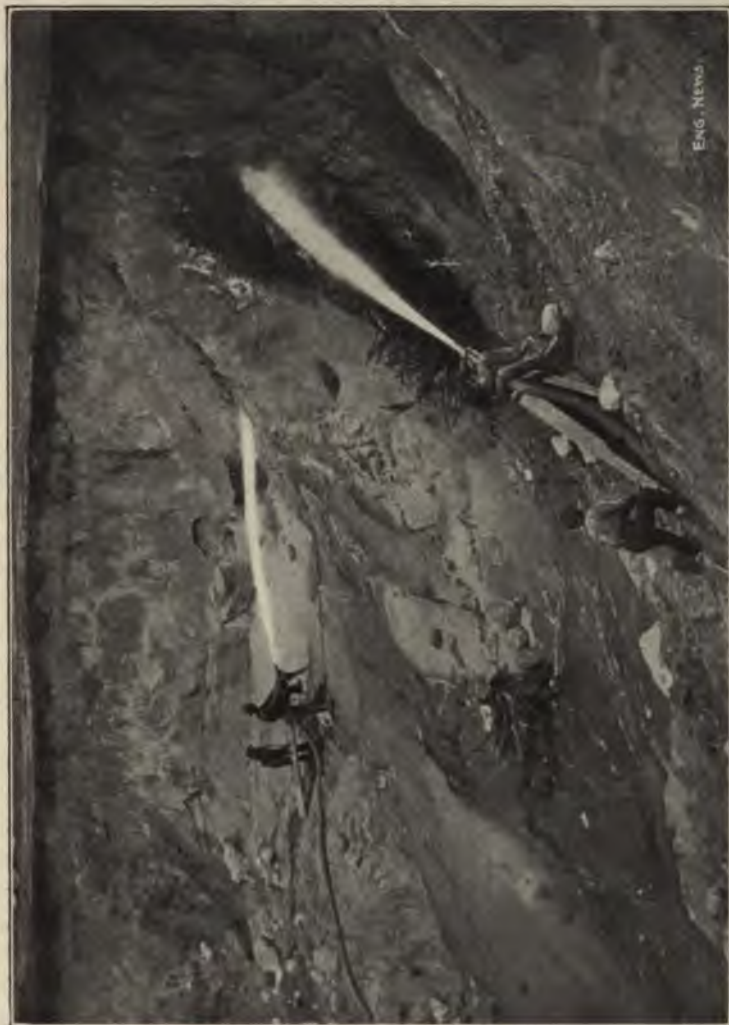
FIG. 139.—HYDRAULIC SLUICING ON THE CROTON DAM, SHOWING THE IMPROVISED NOZZLE CONTROL,
OR HYDRAULIC MONITOR.

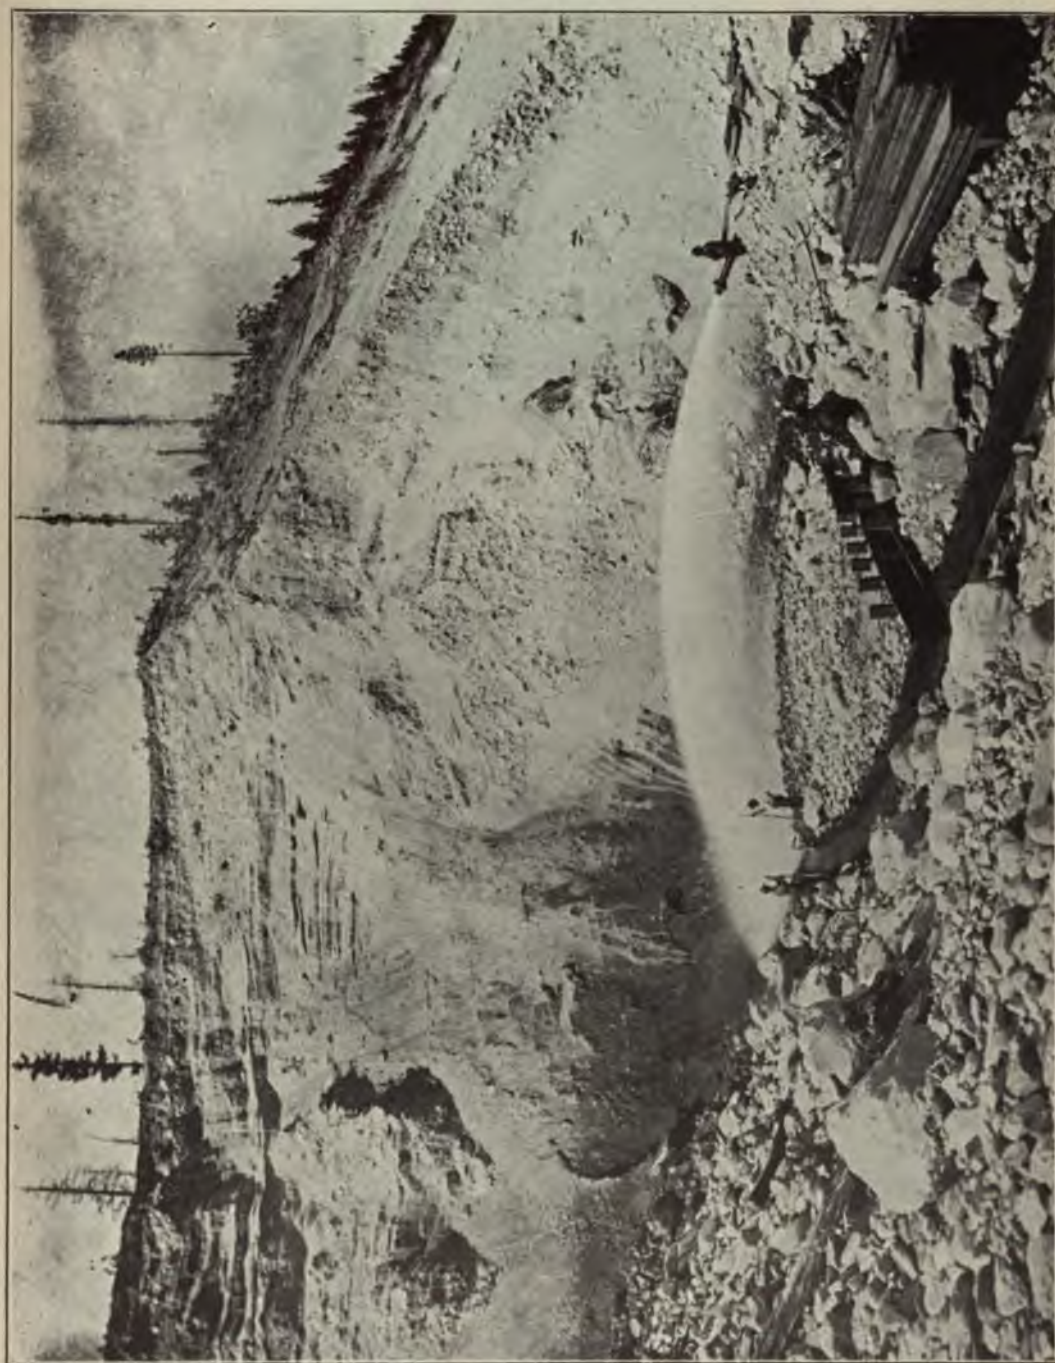
FIG. 140.—HYDRAULIC SLUICING, CANADIAN PACIFIC RAILWAY. VIEW OF PIT, AND HYDRAULIC GIANT AT WORK.

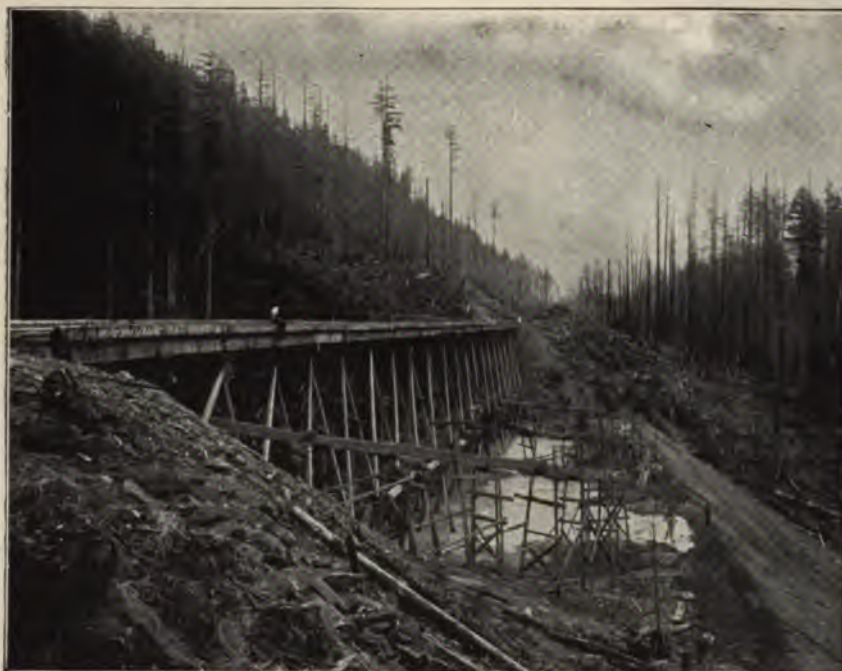
FIG. 143.—NORTHERN PACIFIC RAILWAY. BRIDGE 190.

By courtesy of E. H. McHenry, Chief Engineer, and Charles S. Bihler, Division Engineer, Northern Pacific Railway, the writer has been furnished with the interesting photographs of the work (Figs. 143, 144, 145, and 146), which illustrate the process of hydraulic filling very clearly in all its phases, and demonstrate with what precision embankments can thus be

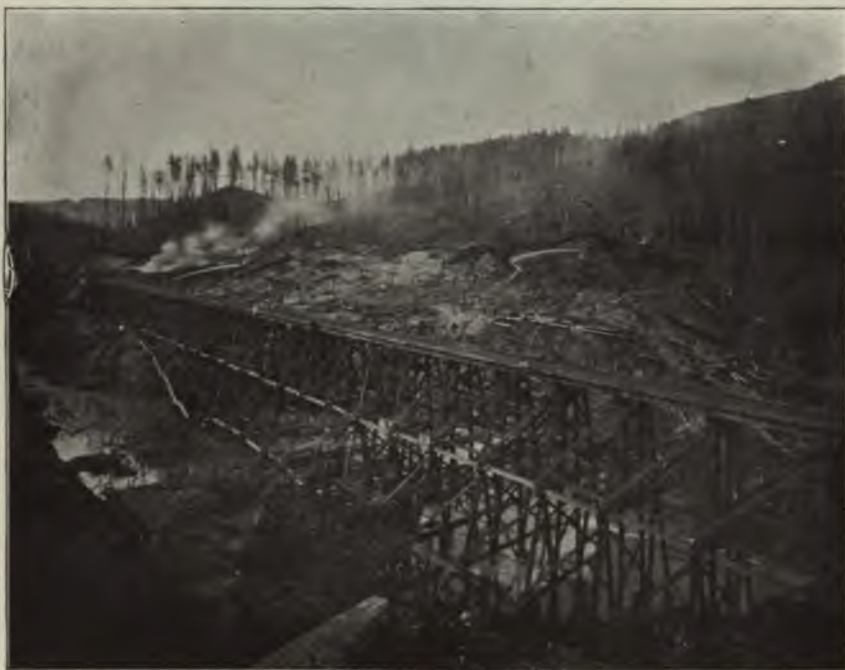
FIG. 144.—NORTHERN PACIFIC RAILWAY. BRIDGE 189, CASCADE MOUNTAINS.

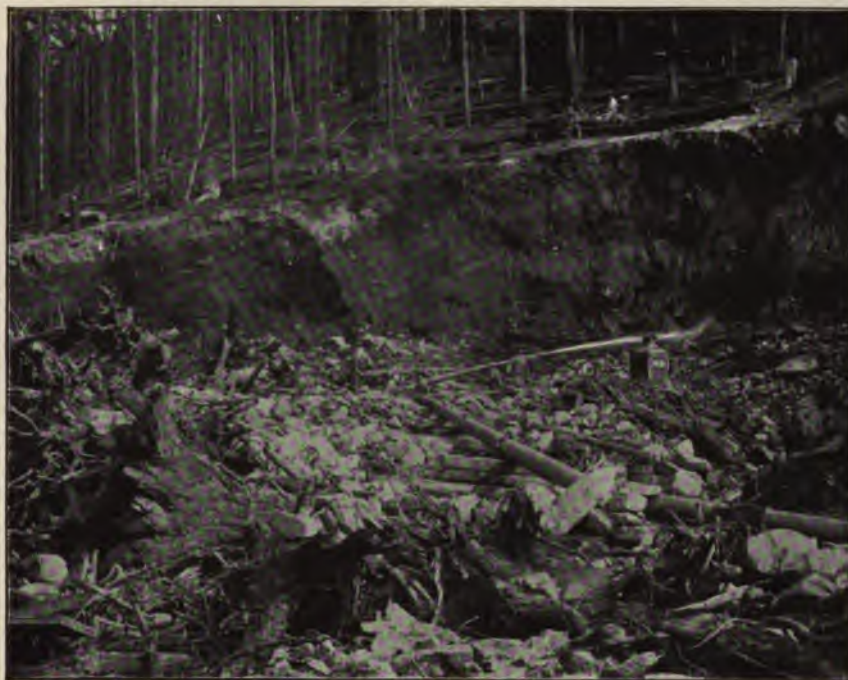
FIG. 145.—NORTHERN PACIFIC RAILWAY, HYDRAULIC-FILL CONSTRUCTION. VIEW IN PIT SHOWING HYDRAULIC GIANT IN ACTION.

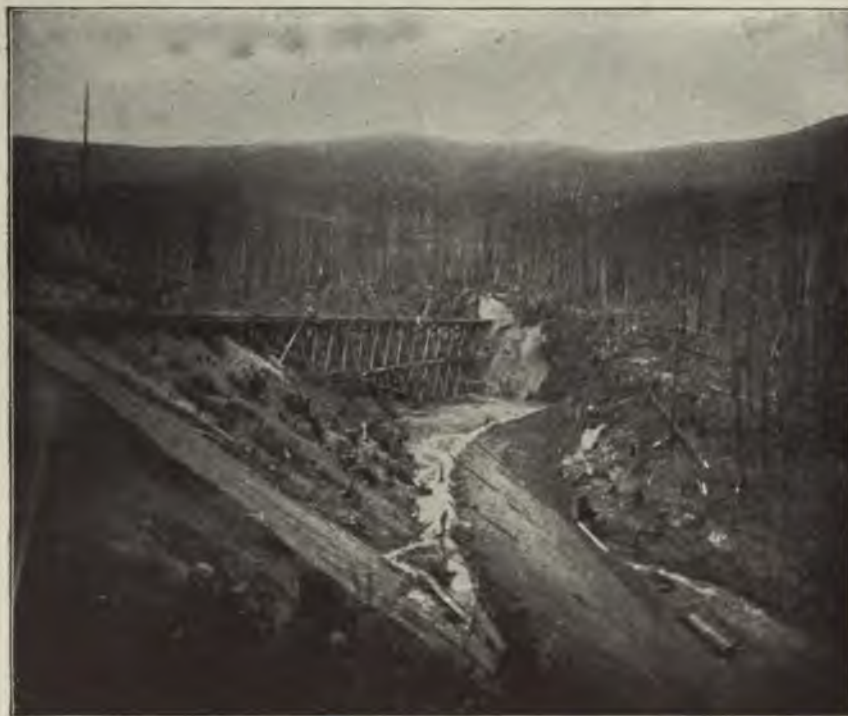
FIG. 146.—NORTHERN PACIFIC RAILWAY, BRIDGE 184. HYDRAULIC FILLING IN PROGRESS.

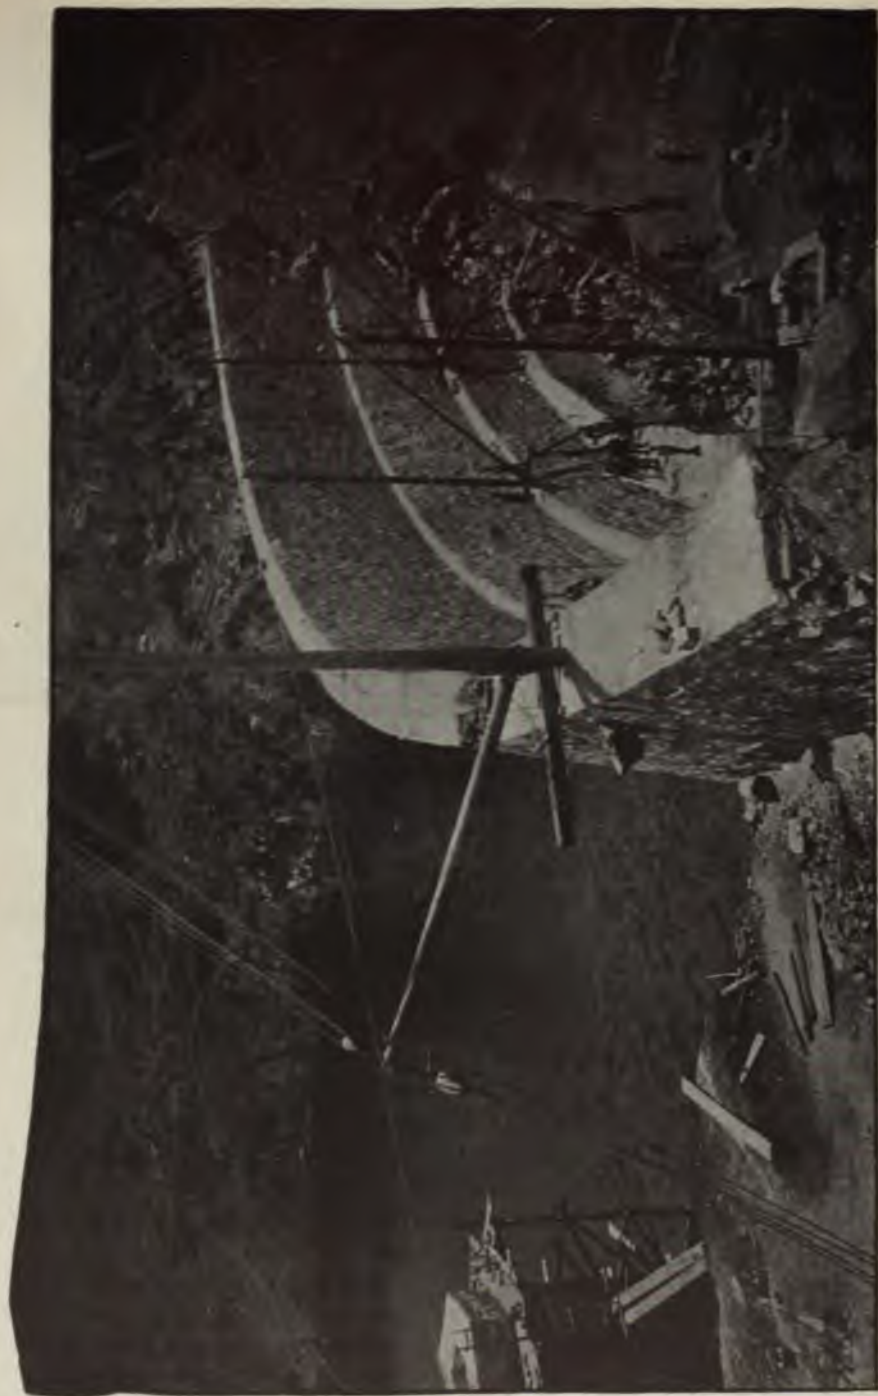
FIG. 150.—ORIGINAL SWEETWATER DAM AS COMPLETED TO THE SIXTY-FOOT CONTOUR.

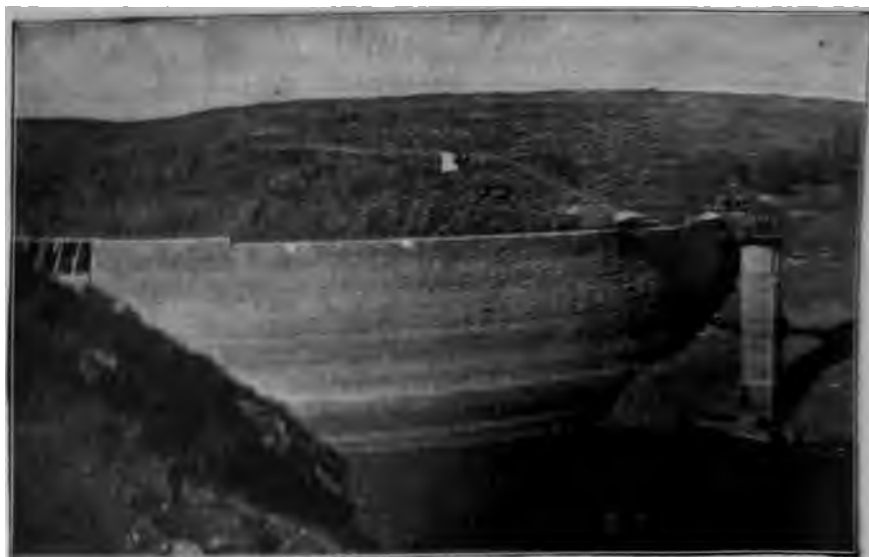
FIG. 152. FACE OF SWEETWATER DAM IN 1899. AFTER TWO YEARS OF DECAY.

ment above the water-line is shown in Fig. 152, a view taken in the summer of 1899 when the reservoir was practically empty.

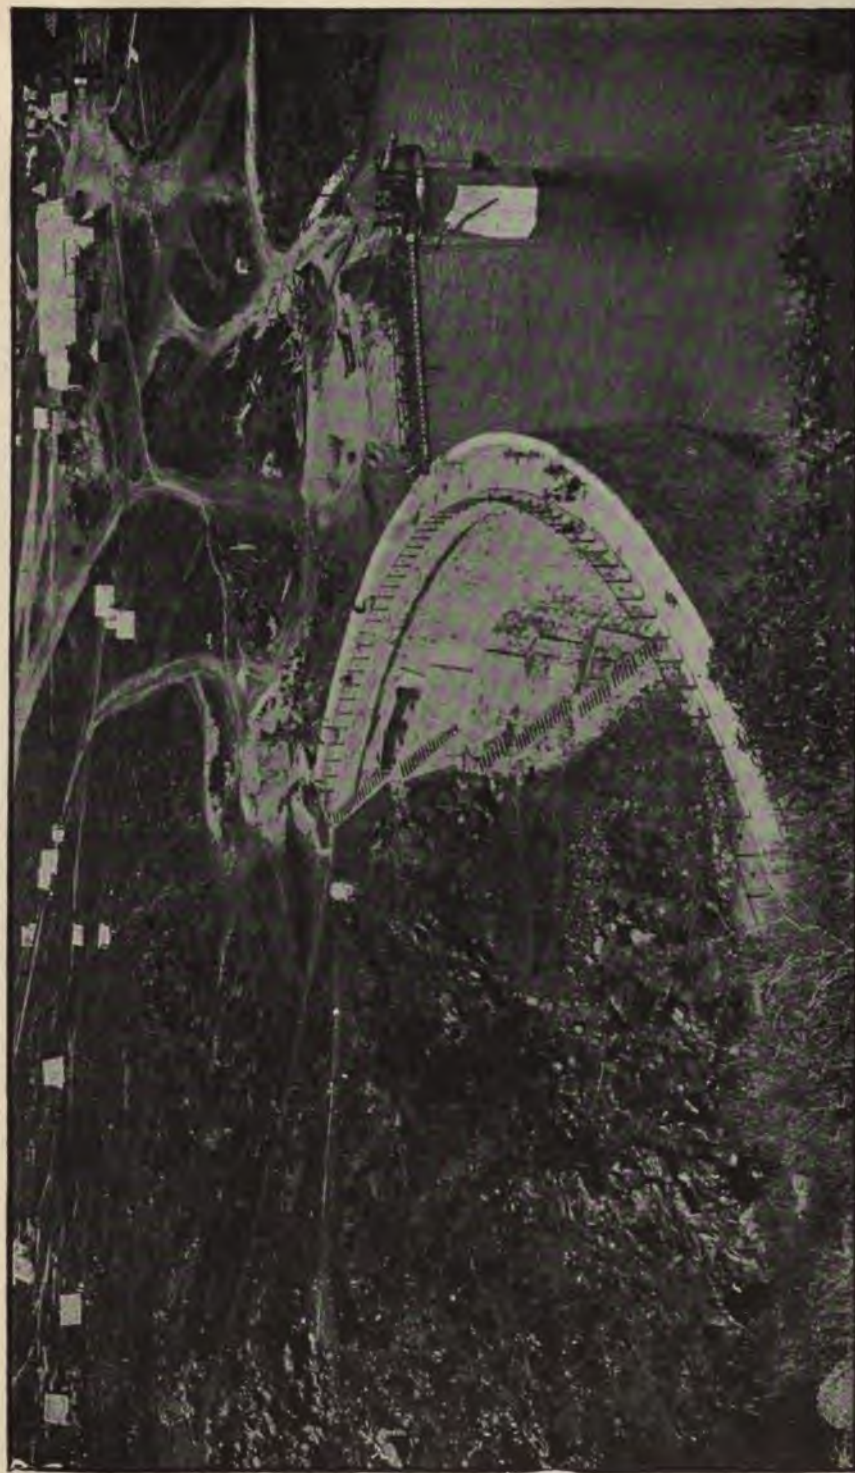
FIG. 154.—SWEETWATER DAM AS FINISHED, APRIL, 1888.

Water is drawn from the reservoir through a tower of hexagonal form, placed 50 feet above the dam, near the center (see Fig. 153), and connected with the dam by a foot-bridge of iron (see Fig. 154).

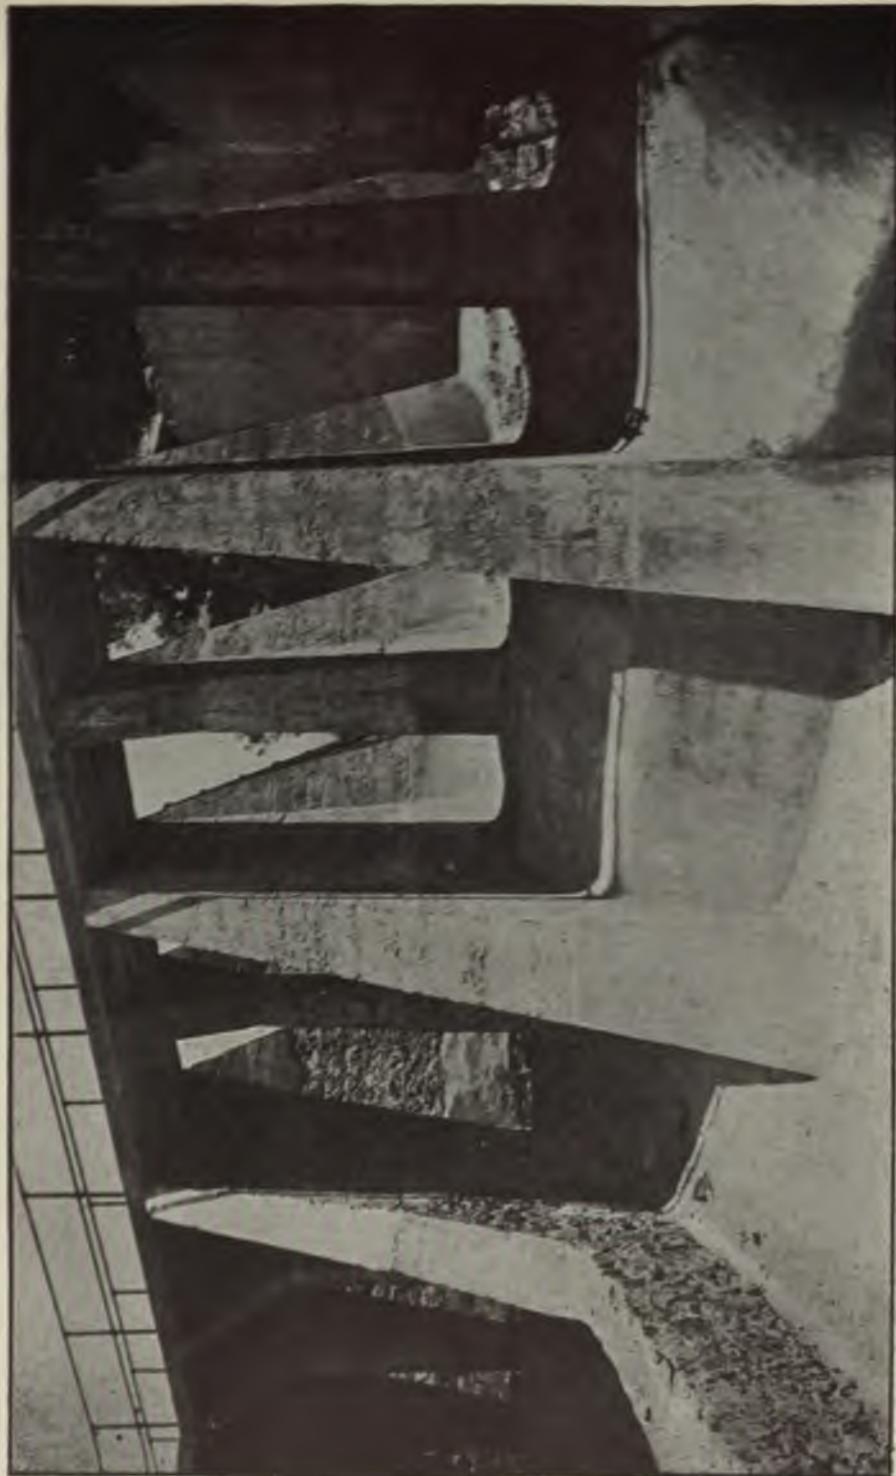
Fig. 157.—Spillway of Sweetwater Dam, seen from below.

1. The parapet of the dam was raised 2 feet and strengthened, so as to permit of permanently holding the water in the reservoir as high as its crest, leaving 200 feet in the center as a weir, 2 feet deep. This weir was arranged with cast-iron frames carrying flashboards, to be removed in extreme floods, as shown in Fig. 157.

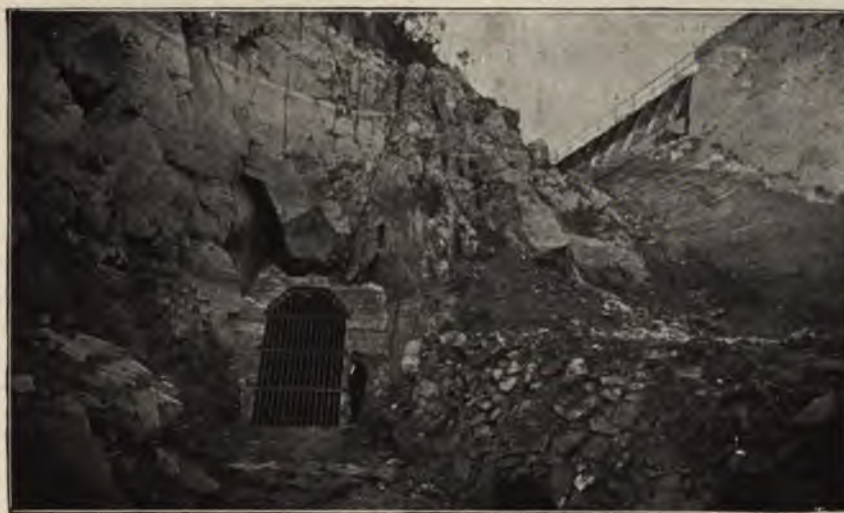
FIG. 163.—SWEETWATER DAM, SHOWING HEAD OF OUTLET TUNNEL AND SPILLWAY.
